INDOOR AIR QUALITY ASSESSMENT

**Sunderland Elementary School
Old Amherst Road
Sunderland, Massachusetts**

Prepared by:
Massachusetts Department of Public Health
Bureau of Environmental Health Assessment
December, 2003

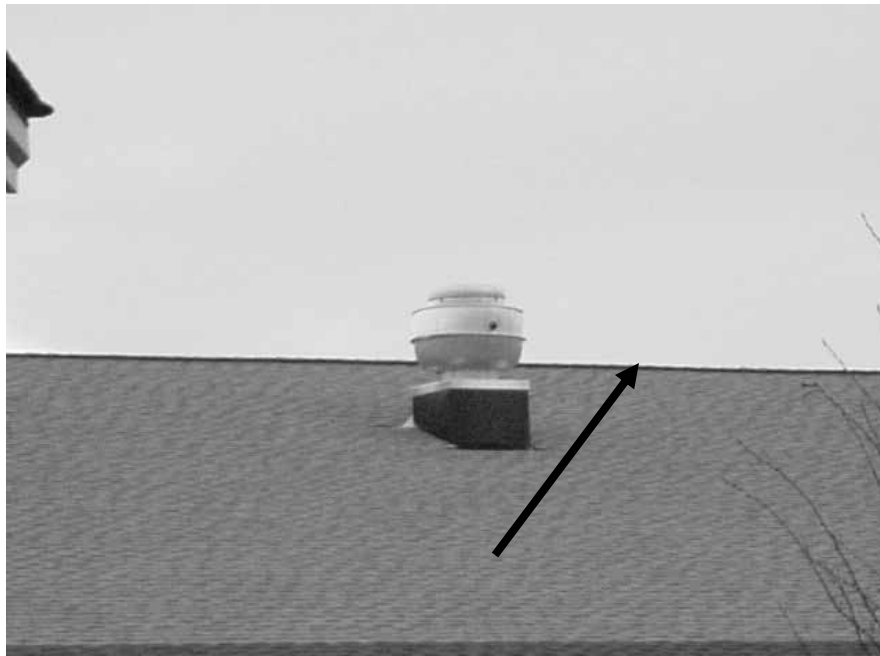
Picture 1

- Restructuring of the roof (Picture 1);
- Removal of GW in a majority of areas in the building;

Restructuring Of the Roof (Note Ridge Vent)

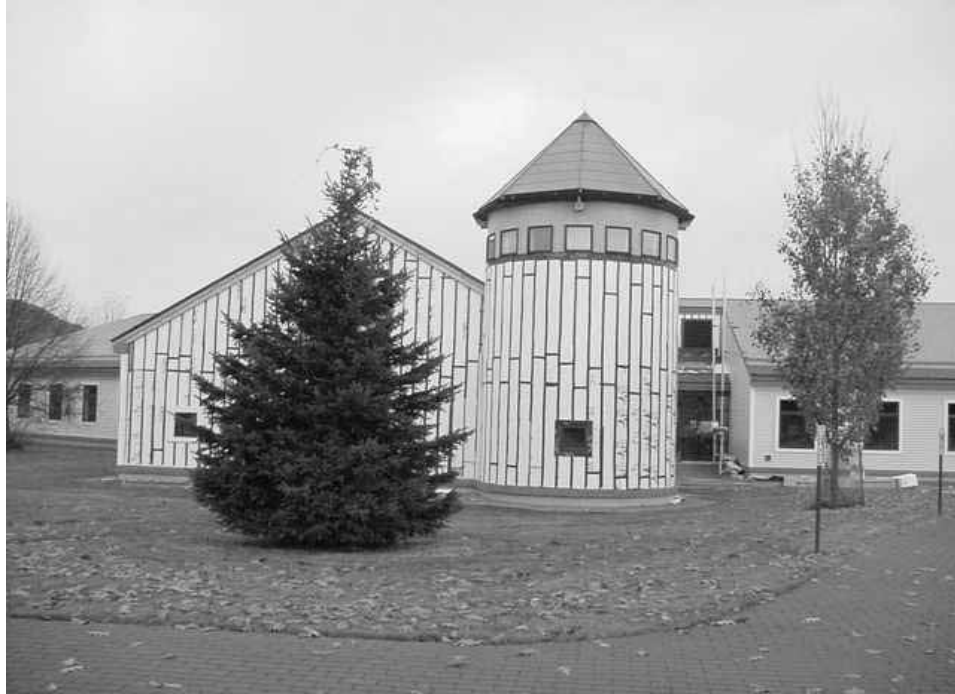
Picture 2

- Installation of a new ventilation system;
- Reconstruction of the exterior walls (Picture 2); and
- Installation of a vapor barrier to the slab.

An Example of Reconstructed Exterior Walls

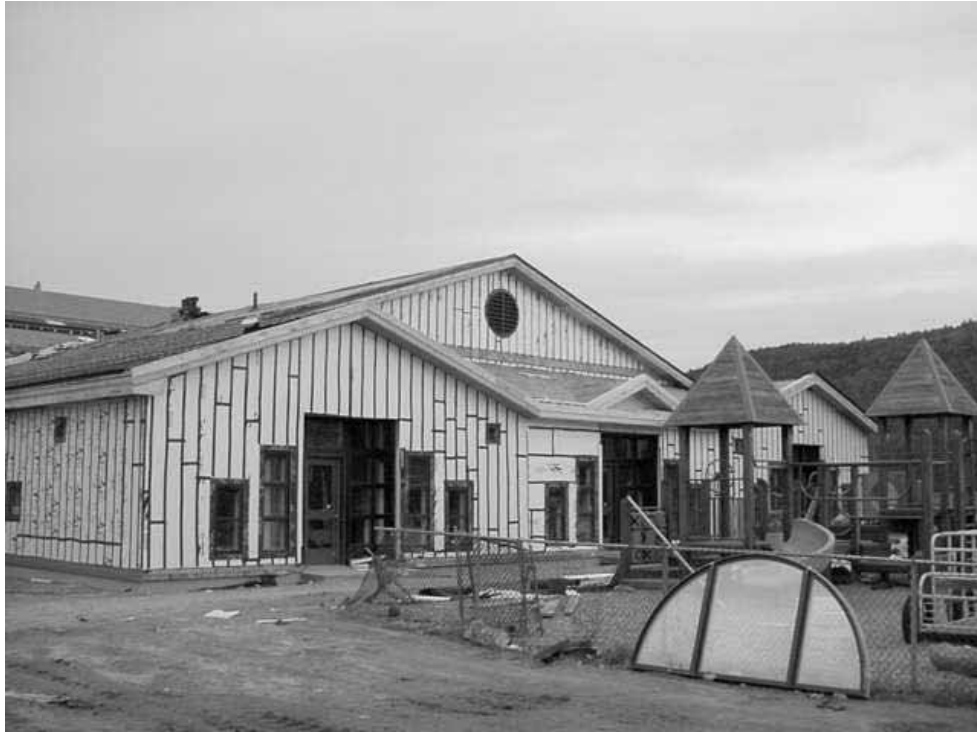
Picture 3

At the time of this assessment, work on the main classroom wing and cafeteria/kitchen areas appeared to have been completed. The kindergarten classrooms and art room section of the building were actively under renovation during this assessment (Picture 3).

Building Wing Consisting of Kindergarten and Art Room

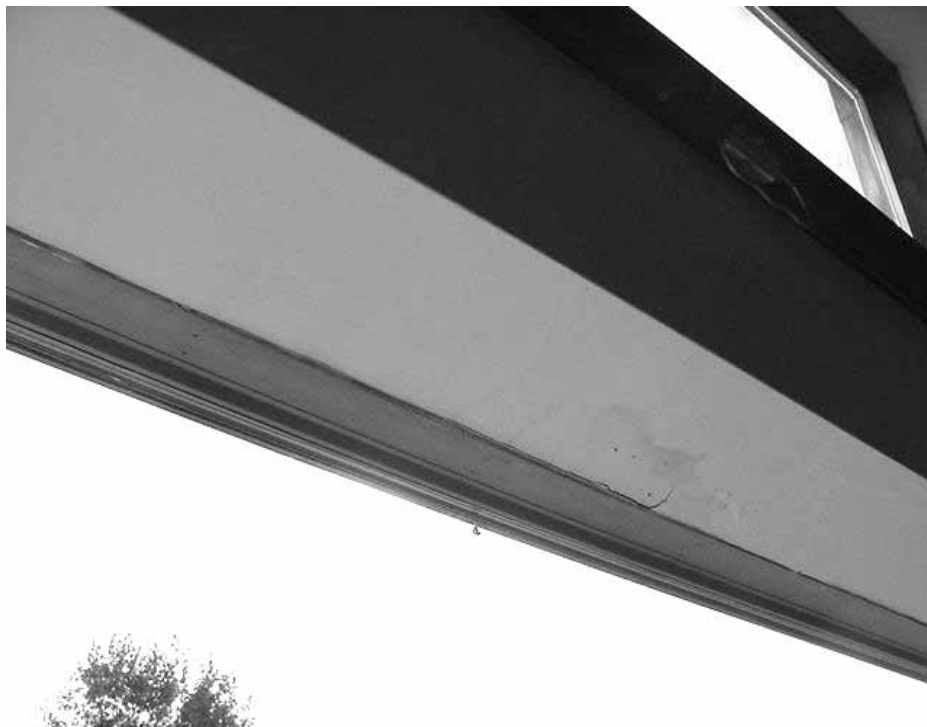
Picture 4

Moisture measurements of GW were taken in areas with a documented history of water damage. In many areas, GW did not have measurable moisture levels. However, a GW window frame in the library (Picture 4) and some GW walls in the art room and

Water Saturated Section of Library Window Frame

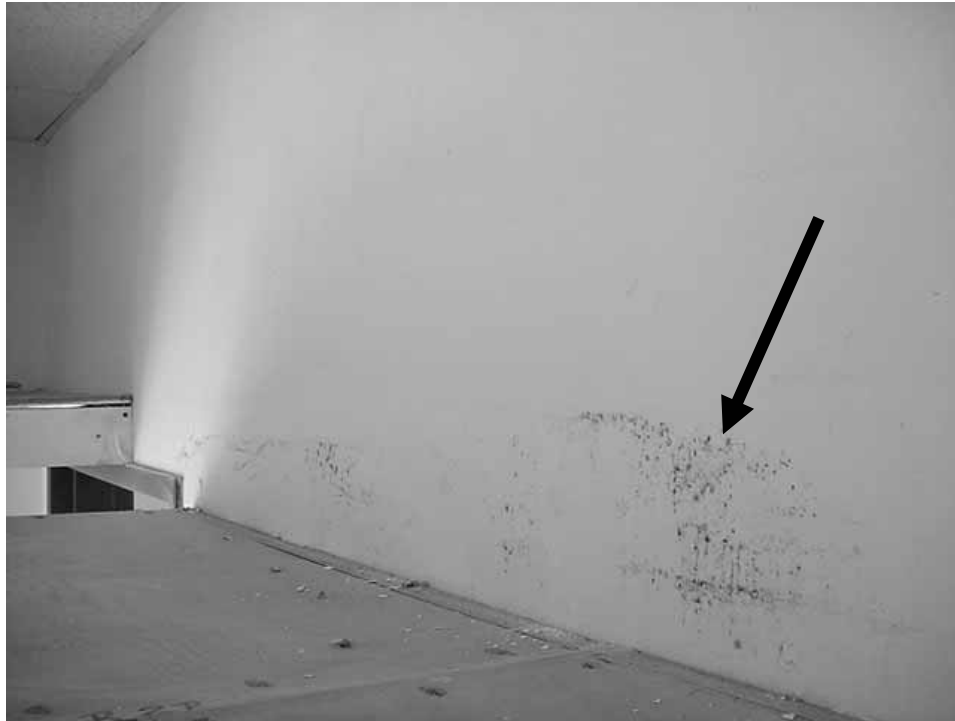
Picture 5

kindergarten classrooms had moisture concentrations ranging from 0.6 percent to saturated. With the exception of the window frame, these moisture concentrations were found in interior walls. Walls were adjacent to kindergarten restrooms, which had ceramic tile walls or walls consisting of wooden cabinets. Since ceramic tiles are non-porous and wood has a higher saturation point than GW, these materials do not readily absorb moisture. Instead, the materials held moisture against GW walls. As a result, GW walls leading to the art and kindergarten rooms became moist and were colonized with mold. Bare GW in one kindergarten classroom had visible mold colonization (Picture 5). Exploratory holes made in kindergarten room wall cavities revealed mold colonization on GW at the floor level (Picture 6). This mold growth indicates that GW was saturated with water.

GW in Kindergarten Classroom with Mold Colonization

1. Replace all GW that have visible microbial growth.
2. Examine the GW behind cabinets in the art room and kindergarten classrooms. If mold colonized, remove and replace GW at least one foot above the floor level.
3. Examine the GW behind tiled walls of the kindergarten restrooms. If mold colonized, remove and replace GW at least one foot above the floor level.
4. Remove water saturated GW from the library window (Picture 4).
5. Discard couch in cafeteria.
6. Clean upholstered furniture in the building according to the schedule recommended above. If not possible/practical, remove upholstered furniture from classrooms.

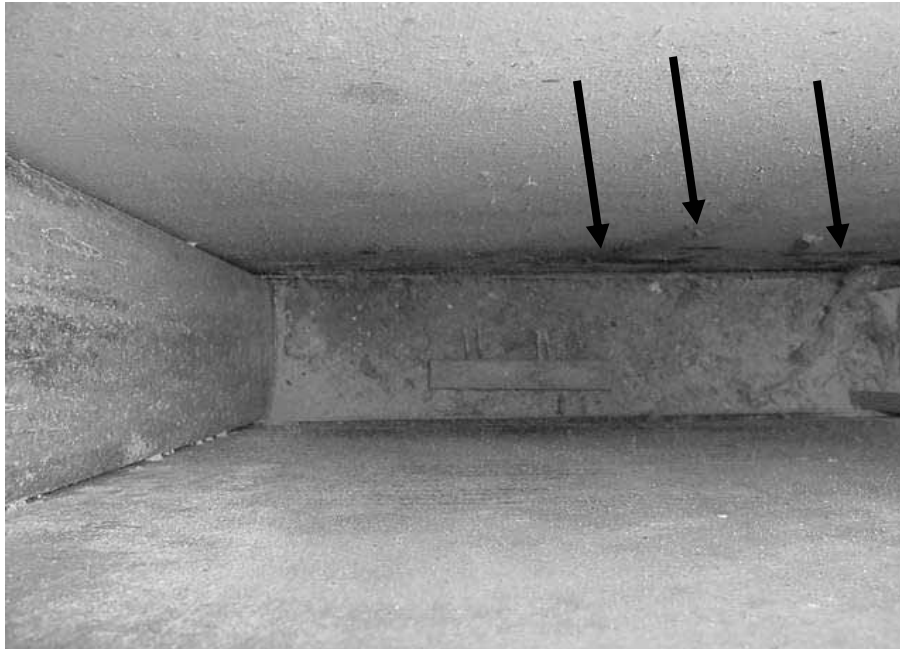
Picture 6

Kindergarten Wall Cavity Mold Colonization in GW at Floor Level

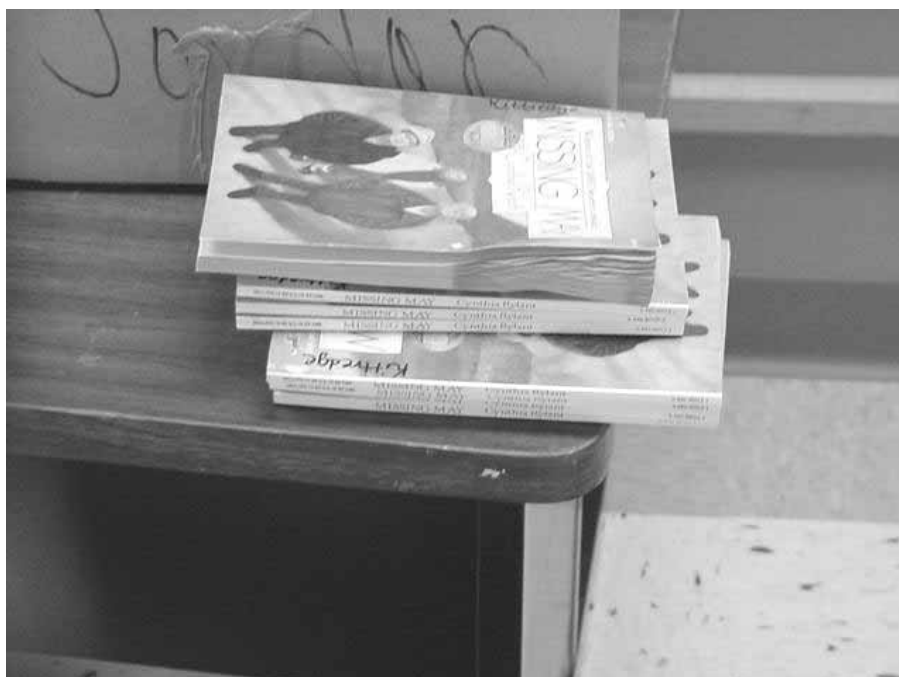
Picture 7

not check every box stored in the library. If materials are found water damaged, as is the book in Picture 7, discarding them is advisable. Sunderland School Department officials reportedly advised teachers to discard water-damaged materials.

Water Damaged Book

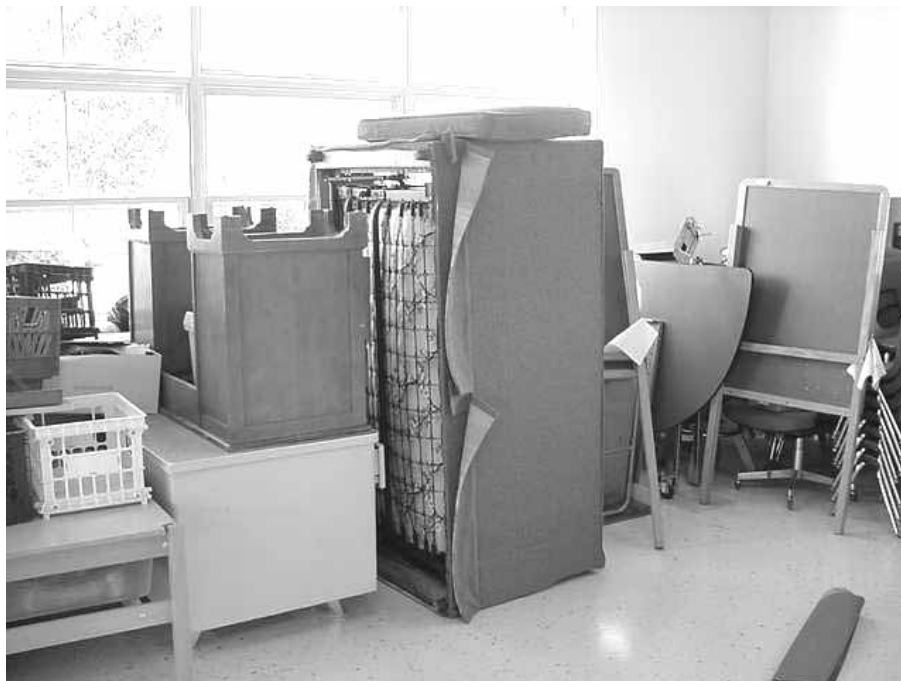
Picture 8

Other materials were found to be mold colonized. A couch with a concealed mattress that is stored in the cafeteria had a distinct musty odor (Picture 8). Upholstered furniture in schools can become a source of environmental pollutants. Upholstered furniture is covered with fabric that comes in contact with human skin. This type of contact can leave oils, perspiration, hair and skin cells. Dust mites feed upon human skin cells and excrete waste products that contain allergens. Moreover, dust mites tend to proliferate when relative humidity levels are above 60 percent (US EPA, 1992). In order to remove dust mites and other pollutants, frequent vacuuming of upholstered furniture is recommended (Berry, 1994). It is also recommended that upholstered furniture present in schools be professionally cleaned on an annual basis. If outdoor conditions or indoor activities (e.g., renovations) create an excessively dusty environment, cleaning frequency should be increased (e.g., every six months) (IICR, 2000). Elevated outdoor levels of airborne particulates can result in increased levels of indoor particulates since pollutants can enter into the building through open windows, doors and filter bypass.

Moldy Couch in Cafeteria

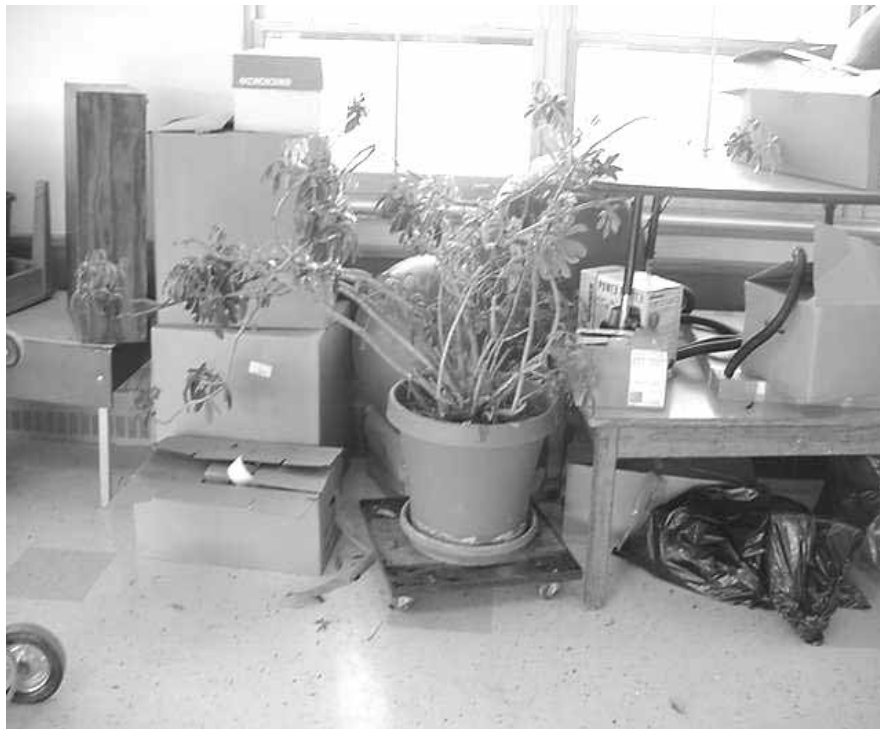
Picture 9

Lastly, the large planter (Picture 9) located in the cafeteria can also be a point for mold proliferation. Plant soil and drip pans can serve as a source of mold growth. Plants should be properly maintained and be equipped with drip pans. To prevent aerosolization of dirt, pollen or mold, plants should be located away from the air stream of mechanical ventilation.

Planter in Cafeteria
